Title no. 99-S34

Behavior of Repaired Cyclically Loaded Shearwalls

by Frank J. Vecchio, Omar A. Haro de la Peña, Filippo Bucci, and Daniel Palermo

Two large-scale, wide-flanged shear walls were subjected to reversed cyclic displacements, resulting in the web elements sustaining heavy damage. The walls were repaired by removing and replacing the damaged concrete, and then were reloaded. Test results indicate that there can be a near full restoration of the walls' strength, stiffness, and energy dissipation characteristics. However, it is shown that the repair scheme, strength of the repair concrete, and residual damage in the unrepaired zones can have a significant influence on subsequent behavior, particularly in altering the mode of failure. It is also shown that properly accounting for previous loading, residual damage, and repair sequence is critical to obtaining accurate predicted responses from analytical procedures. The data from this test series, augmenting other data available in the literature, will be useful in calibrating improved analytical methods as they are developed.

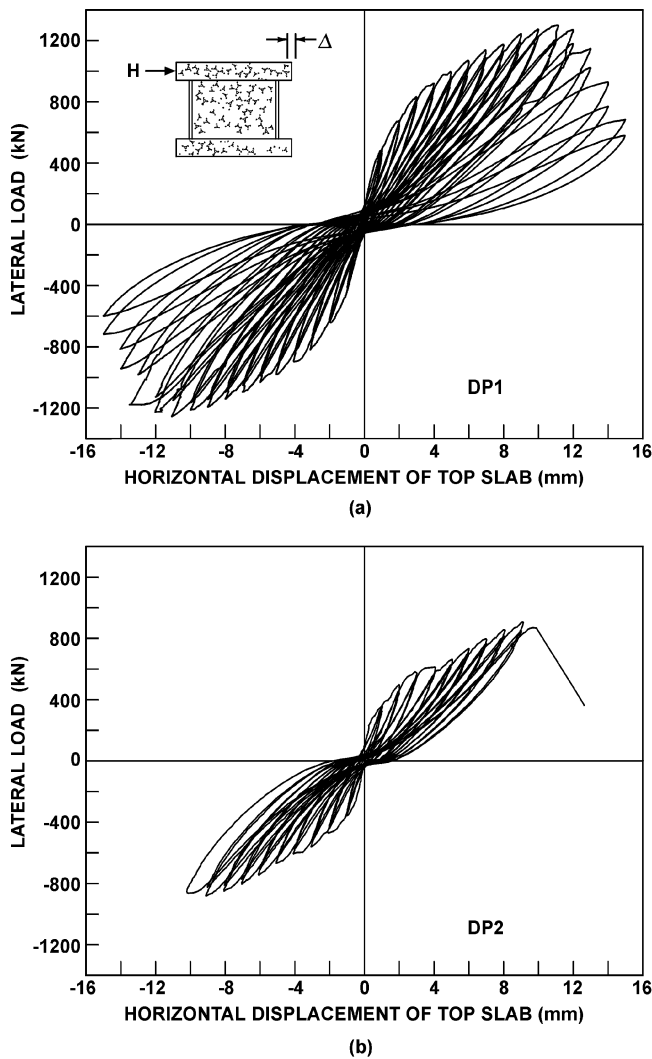
Fig. 4—Load-displacement responses of original walls: (a) Specimen DP1; and (b) Specimen DP2.

Specimen DP1 was subjected to a constant axial load of 1200 kN, and incrementally increasing reversed cyclic lateral displacements. The wall was able to sustain a maximum lateral load of 1298 kN, at a corresponding lateral displacement of 11.1 mm. Loading was continued well into the postpeak range of response, with the lateral load resistance decaying to approximately 580 kN at a displacement of 15 mm. The wall sustained severe and widespread crushing of the concrete in the web, with the final failure mechanism involving the formation of six vertical slip planes within the web. Some local yielding of the horizontal reinforcement in the web was recorded; however, no yielding of any vertical reinforcement in the web was detected. The flange walls experienced some flexural cracking, up to widths of 1.1 mm, but remained relatively undamaged. There was no evidence of any concrete distress nor was yielding of either the horizontal or vertical reinforcement detected. The load-displacement response curve for Specimen DP1 is given in Fig. 4(a). Palermo¹³ gives a full discussion of the test results.

significant was the pronounced damage in the web-flange joint regions, with notable punching of the web through the flanges. Yielding of the reinforcement was not detected anywhere in the web or flanges by the electrical strain gages. Concrete surface strain readings, however, indicated probable local yielding of the flange vertical reinforcement. Flexural cracks in the flanges approaching 1 mm width further suggested local yielding had occurred. The load-displacement response curve for Specimen DP2 is given in Fig. 4(b).

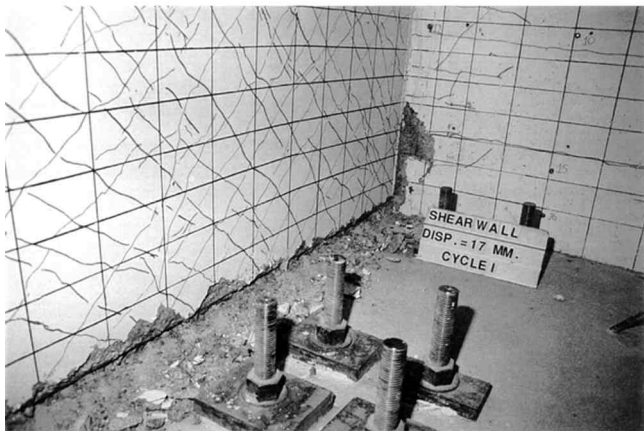
Fig. 6—Specimen DP1R: (a) at ultimate load; and (b) at failure.

In the testing of Specimen DP1R, web shear cracks became apparent at displacements as low as 1.0 mm, much sooner than evident in the original wall (Specimen DP1). Owing to the precracked nature of the flange walls, lateral load stiffness at low displacement levels was somewhat reduced. Post-cracking stiffness at intermediate load levels, however, was comparable to that of the original wall. (Note that the strength of the web concrete in the repaired wall, however, was 44.0 MPa, as opposed to 21.7 MPa in the original wall.) At a displacement amplitude of 7.0 mm, the web was extensively cracked throughout, with maximum crack widths of 0.5 mm recorded. Crack patterns and crack widths, measured using a surface gage with a precision of 0.05 mm, remained essentially stable thereafter. During the first excursion to 11 mm (0.55% drift), the maximum load capacity of 1192 kN was achieved. Figure 6(a) shows the condition of the wall at this load stage. Load resistance gradually diminished

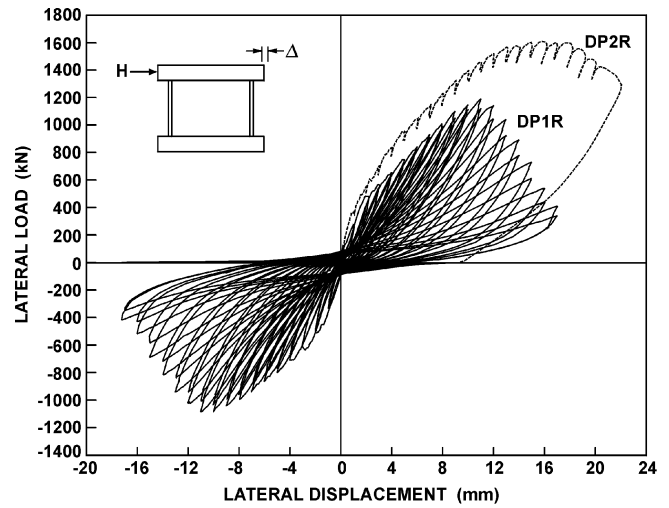
Fig. 7—Load-displacement responses of repaired walls.

thereafter. At displacement amplitude of 17 mm, the load resistance decayed to approximately 350 kN. The load-deformation response, reproduced in Fig. 7, was characterized by highly pinched hysteresis curves indicative of shear-dominated behavior. Crushing and localized spalling of the concrete was noted at displacement levels of 11 mm and above. At 12 mm displacement, the first signs of a potential punching of the web through the base of the flanges became evident. Finally, at 17 mm displacement (0.85% drift), the wall sustained a sliding shear failure along the base (just above the repair interface), coupled with punching of the web through the flanges (Fig. 6(b)). Minor localized yielding of the vertical reinforcement, in both the web and flanges, was observed in the postpeak response. Bucchi¹⁴ provides a full description of the test results.

for Specimen DP2R). Comparing the calculated response with the experimentally observed response (Fig. 7(a)), the behavior is reasonably well simulated. The final failure mode was also correctly predicted, involving the formation of a sliding shear plane at the base. The slightly overestimated strength and stiffness can be attributed to two factors: the two-dimensional representation of the wall overestimated the contribution of the flanges, and the analysis program used preliminary cyclic loading/unloading and damage models that are in need of further development. Work is progressing in this regard.

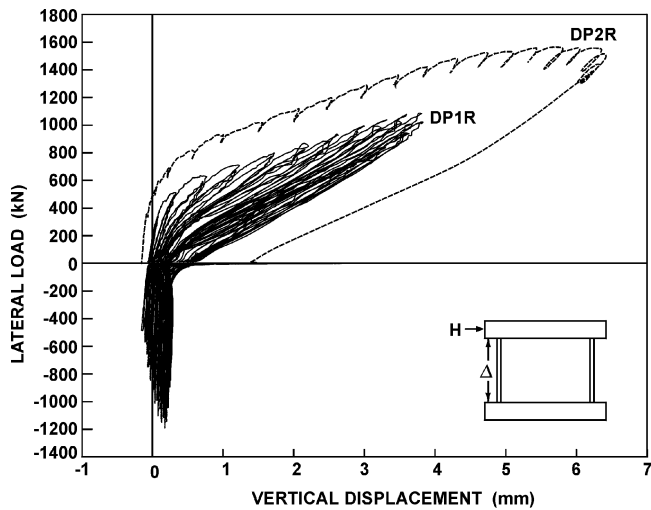
Fig. 9—Flange elongation.

The test data that are especially useful in understanding behavior and corroborating analytical models are those of a second-order nature, describing subtleties in response. Among them is the elongation of the flange walls, particularly in walls subjected to reversed cyclic loading where ratcheting (due to reinforcement yielding) may be prevalent. Figure 9 shows the progressive elongation of one of the flange walls in Specimen DP1R. Elongation of the tension flange in Specimen DP2R is also shown. Note that in the postpeak response of Specimen DP1R, as the resistance force diminishes with increased lateral displacements, there is some accumulation in the residual displacement. The effect is minor, however, and suggests that yielding of the reinforcement, if any, was minimal. The increasing flange elongation in the postpeak response of Specimen DP2R, however, confirms the influence of yielding.

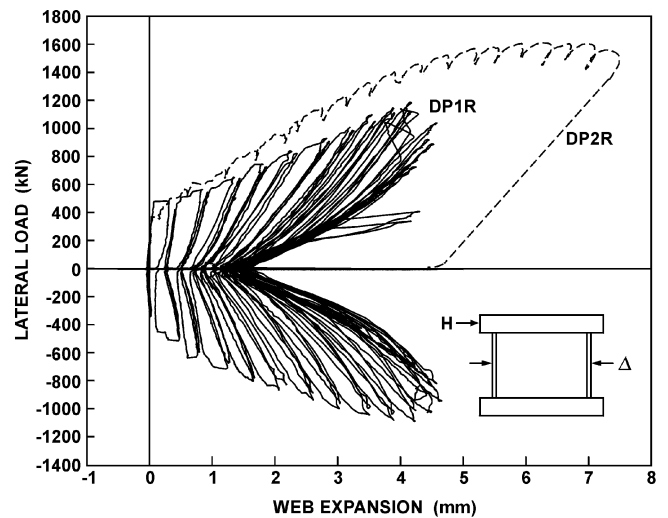
Fig. 10—In-place expansion of web at midheight.

Another important second-order mechanism is that of the in-plane horizontal expansion of the web wall at midheight. As previously discussed by Vecchio,¹⁶ capturing this behavior in nonlinear finite element analyses is critical to accurately calculating the load capacity and failure mode of the structure. Figure 10 shows the web expansions measured in Specimens DP1R and DP2R. (The expansion was determined from the difference in readings from two horizontal extensometers placed on either edge of the web. See sketch in Fig. 10.) Note that even in the postpeak load stages, the wall continued to expand.

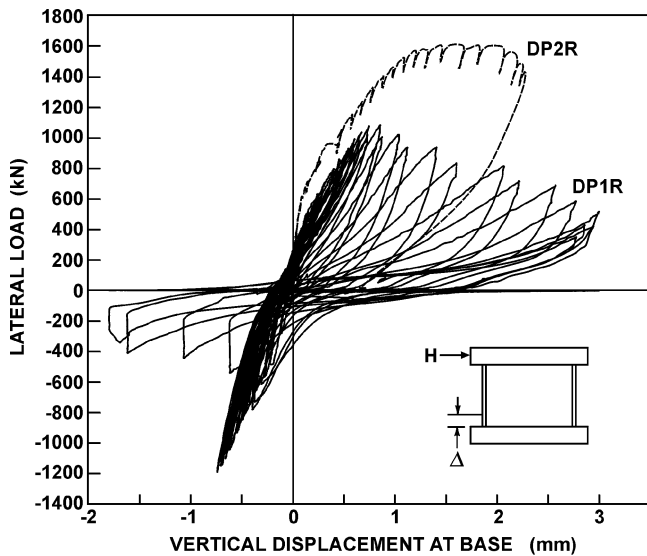
Fig. 11—Vertical displacement at base of flange.

slab, to a depth of 300 mm, and then put in place with epoxy-grouting.) Figure 11 shows the vertical displacement of the flange wall relative to the base, measured at a short height above the base (180 and 200 mm for Specimens DP1R and DP2R, respectively). With both Specimens DP1R and DP2R, comparing Fig. 11 with Fig. 9, one sees that a relatively large proportion of the total flange elongation occurred at the base region. The majority of this displacement appeared as a crack at the base of the wall. Coupling this with the observation that the reinforcement strains were post-yield but not excessive, one may conclude that some amount of bond slip in the anchorage zone of the vertical bars had taken place.

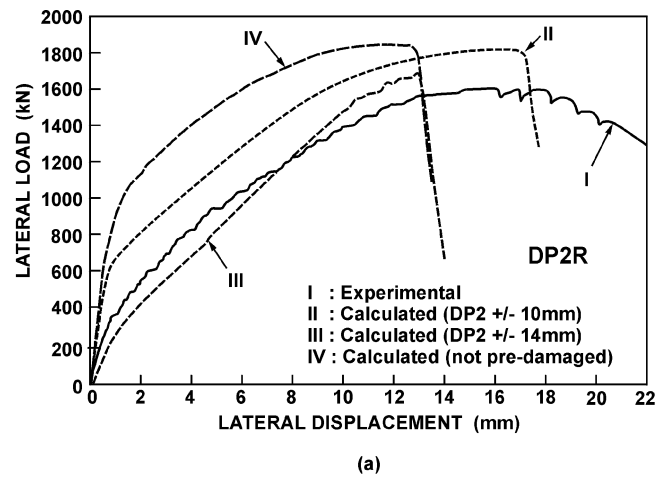
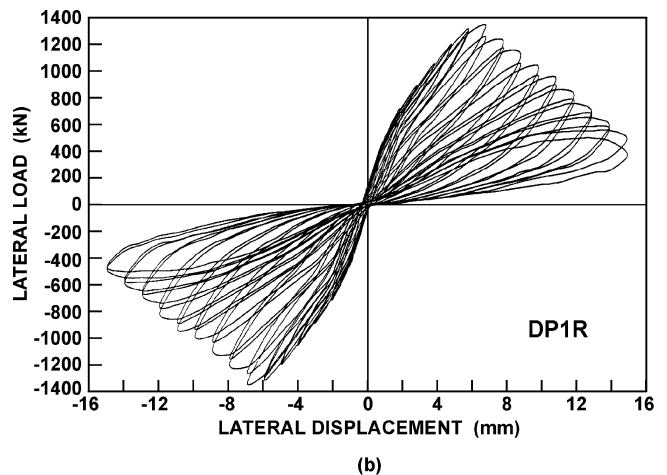
Fig. 12—Calculated load-displacement responses of repaired walls: (a) Specimen DP2R; and (b) Specimen DP1R.

damaged web elements disengaged, new (undamaged) web elements engaged, and the structure reloaded. The experimentally observed response (Curve I) is compared with the resulting calculated load-deflection response (Curve II) in Fig. 12(a). The calculated response is somewhat stiffer and stronger. Some of the discrepancy is attributable to the two-dimensional representation of a structure that, in fact, involves complex three-dimensional behaviors (that is, web-flange punching, shear lag in flanges) but some is also due to the original phase of the analysis underestimating the extent of damage in the structure. The analysis was repeated, pushing the wall to ± 14 mm displacement amplitude and hence taking it well into a postpeak (highly damaged) condition. The repair was then simulated and the wall reloaded. The calculated response is shown as Curve III in Fig. 12(a). It is seen that strength and stiffness are more accurately calculated, but the ductility is now underestimated. Hence, overestimating the damage in the original wall resulted in an overly weakened predicted response for the repaired wall, primarily from excessive damage in the flanges. The predicted response, where Specimen DP2R is analyzed as if not previously loaded, damaged, or repaired (that is, new), is shown as Curve IV in Fig. 12(a). A significant overestimation of the strength and stiffness of the wall results, coupled with a more brittle predicted failure mode.

Figure 12(b) shows the cyclic displacement response of repaired Specimen DP1R, computed using a two-stage, two-dimensional finite element analysis (as previously described
